## MS4 Annual Report Transmittal Form

# 2022 MS4 ANNUAL REPORT

Town of Granby, Connecticut

This report documents Granby's efforts to comply with the conditions of the MS4 General Permit to the maximum extent practicable (MEP) from January 1, 2022 to December 31, 2022.

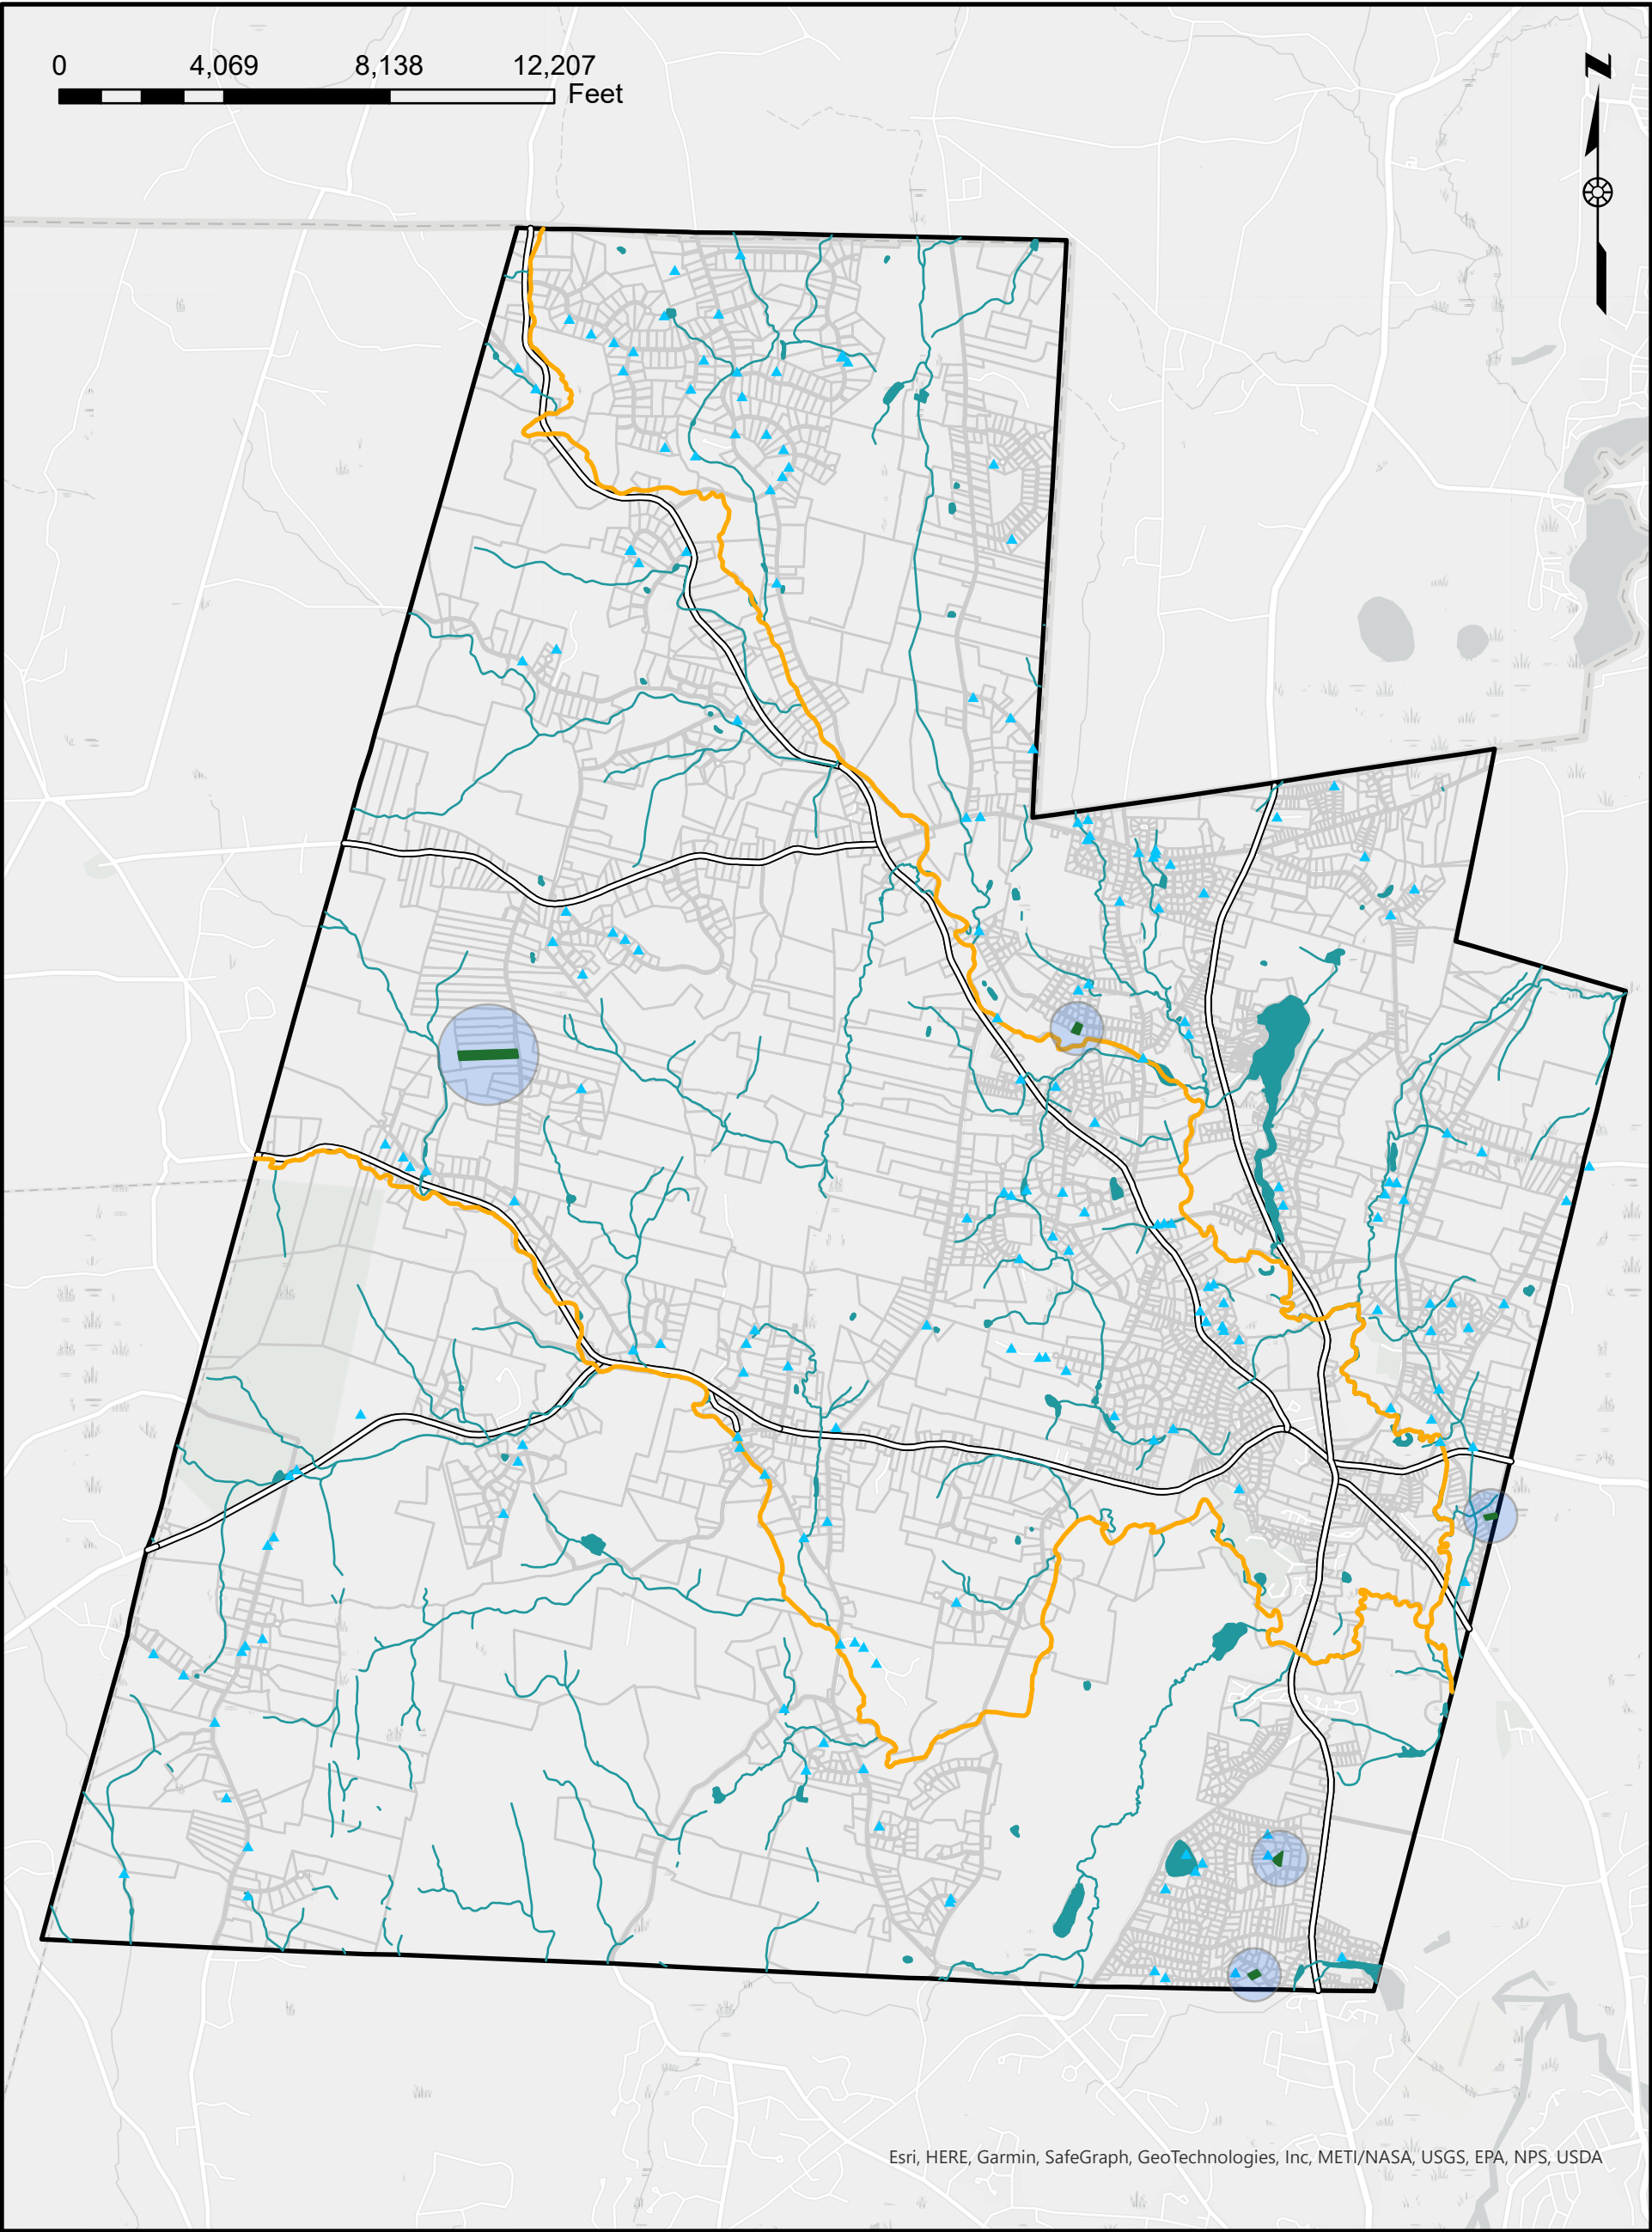
2022 Septic Failures

| Method used to track illicit discharge reports | Location and nature of structure with failing septic systems | Actions taken to respond to and address the failures | Impacted waterbody or watershed, if known | Dept. / Person responsible |
|---|--|--|---|---|
| <i>Farmington Valley Health District (FVHD)</i> | <i>23 Glen Road- 80 year old septic system</i> | <i>Old septic system was replaced following an evaluation by FVHD. New sewage disposal system was approved for a permit to discharge.</i> | <i>Wetlands in close proximity to the property with possibility of impact.</i> | <i>FVHD</i> |
| <i>Farmington Valley Health District (FVHD)</i> | <i>21 Oakwood Drive- Unknown</i> | <i>Septic system was evaluated and given a permit for replacement by FVHD. Reason not explained in the report.</i> | <i>Munnisunk Brook and wetland south of property with potential for impact.</i> | <i>FVHD</i> |
| <i>Farmington Valley Health District (FVHD)</i> | <i>31 Harmony Hill Road- Failed septic inspection</i> | <i>FVHD evaluated site and recommended the installation of a new septic system. A proposal for the septic system repair was submitted by a licensed installer.</i> | <i>Potential impact to East Branch Salmon Brook.</i> | <i>FVHD</i> |
| <i>Farmington Valley Health District (FVHD)</i> | <i>6 Glen Road- 1000 gallon septic tank leaking with roots invasive to the system.</i> | <i>Site evaluation conducted by FVHD. Recommended installation of a new septic system.</i> | <i>Wetlands in close proximity to the property with possibility of impact.</i> | <i>FVHD</i> |
